REPORT

Groundwater Survey at Marumba village

Nanyumbu district – Mtwara region

October 2015

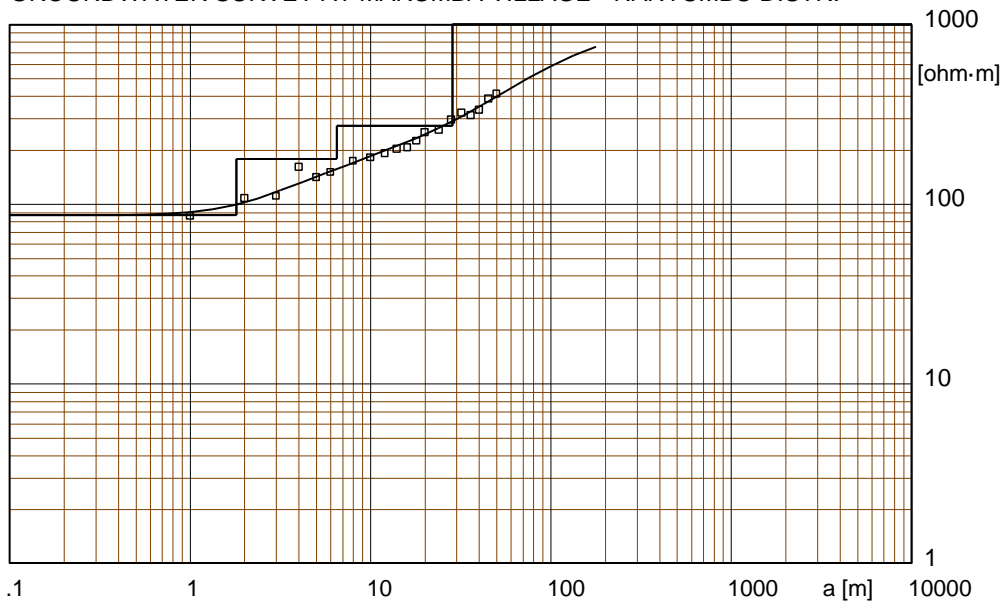
Electrical sounding Wenner - VES1 MARUMBA.WS3

VES No. 1 At 60m North of Zahanati, NOT SELECTED

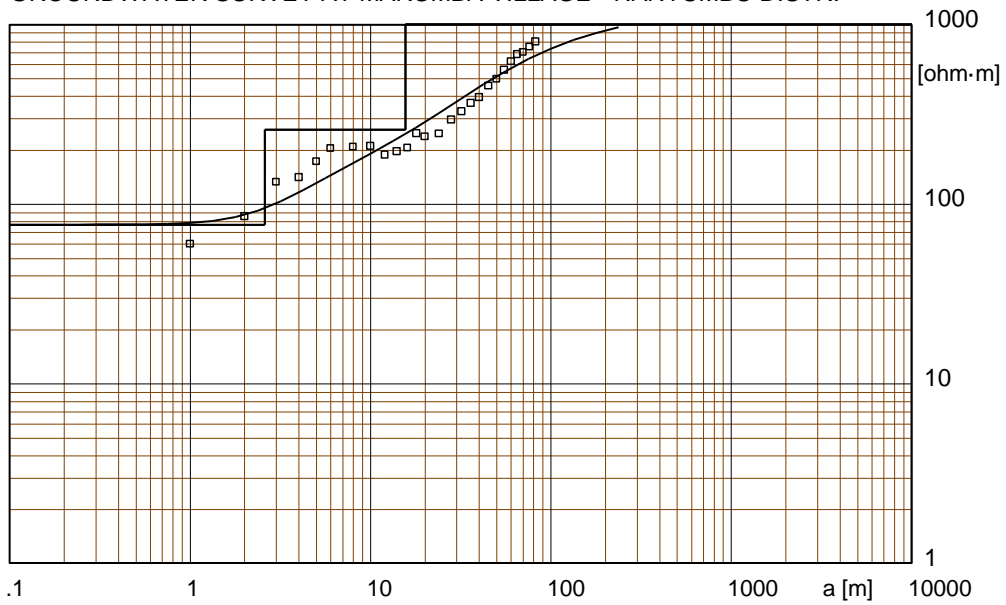
Electrical sounding Wenner - VES2 MARUMBA 2015.WS3

VES No. 2 At 150m East of Zahanati. Selected as 3rd Choice. Drill 50m

Third Choices: VESs Nos. 2 located at about 100m East of Dispensary (Lilungu area).

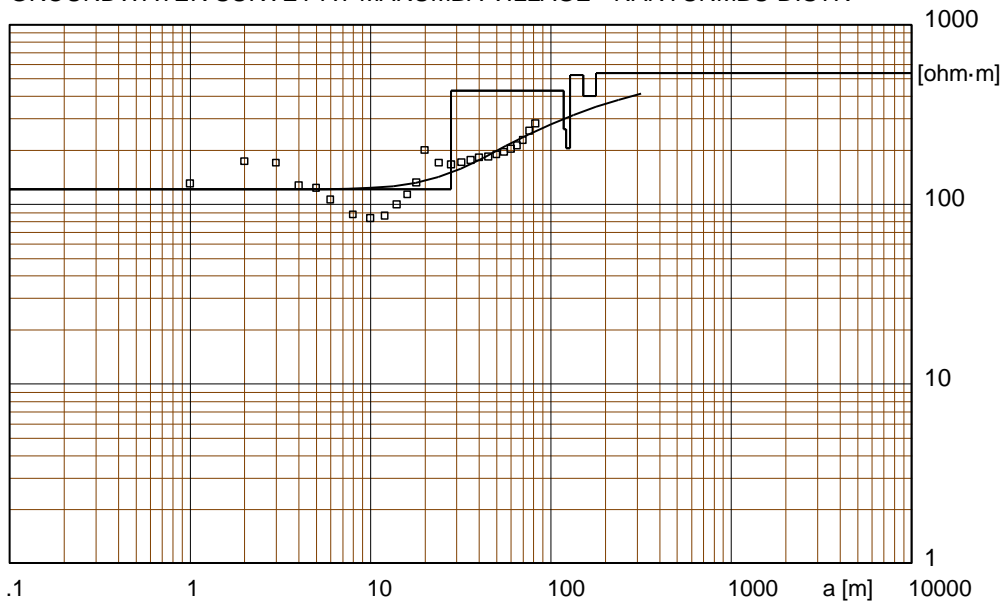
Electrical sounding Wenner - VES3 MARUMBA 2015.WS3

VES No. 3 At Namihalau valley. Selected as 1st Choice. Drill 50m deep

First Choice: VES No. 3 located in Namihalau valley, Drilling depth recommended is 90m;

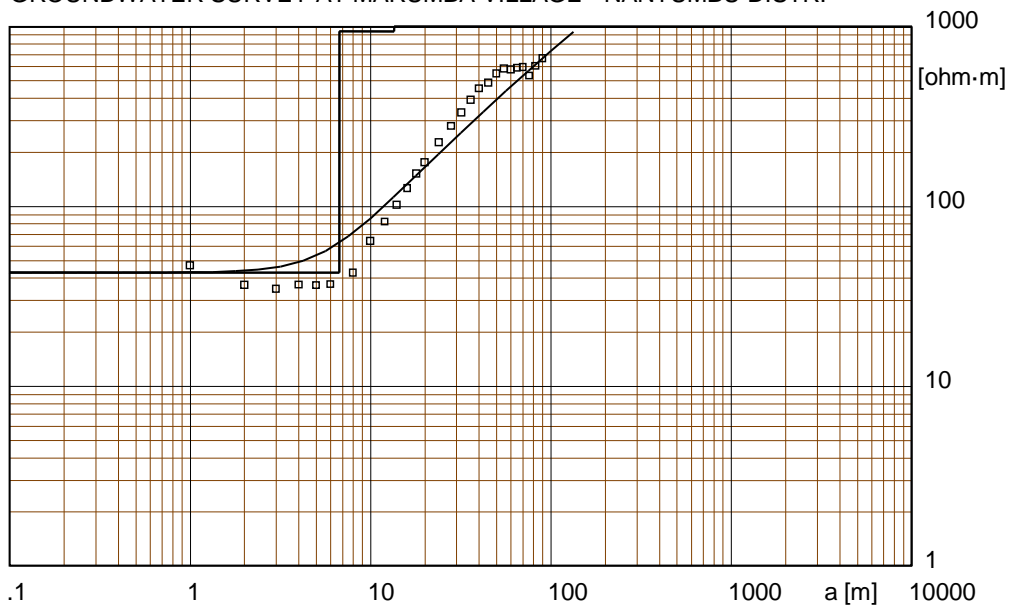
Electrical sounding Wenner - VES4 MARUMBA 2015.WS3

VES No. 4 Namashapwe valley. 2nd Choice. Drill 100m

Second Choice: VES No. 4 located in Namashapwe valley, Drilling depth is 50m;
